**Question: *What causes streaking on a tennis court surface?***

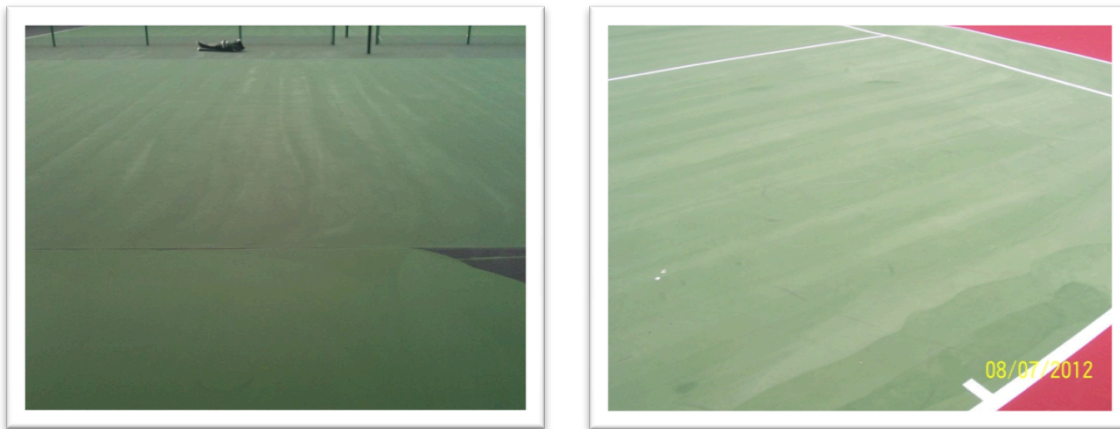
Here are a few pictures that demonstrate streaking from over dilution:

**Answer:** There are many variables that may contribute to streaks and splotches on a tennis court surface. Excessive streaking, in most cases, is from over dilution of the color coating materials. There is an acceptable range of dilution stated on the specification sheets and labels, depending on pavement temperatures. Make sure not to exceed this range, and if needed, wait until cooler periods to apply your next coat. Morning is ideal for application during very hot days. If the ambient temperatures are above 90 degrees Fahrenheit, it may be best to schedule applications during the morning.
